AVIATION INVESTIGATION REPORT
A01H0003

ENGINE POWER LOSS - FORCED LANDING

HORIZON AEROSPORTS (1982) LTD.
PILATUS PC-6T C-GROO
ABBOTSFORD, BRITISH COLUMBIA
22 JULY 2001

Report Number A01H0003

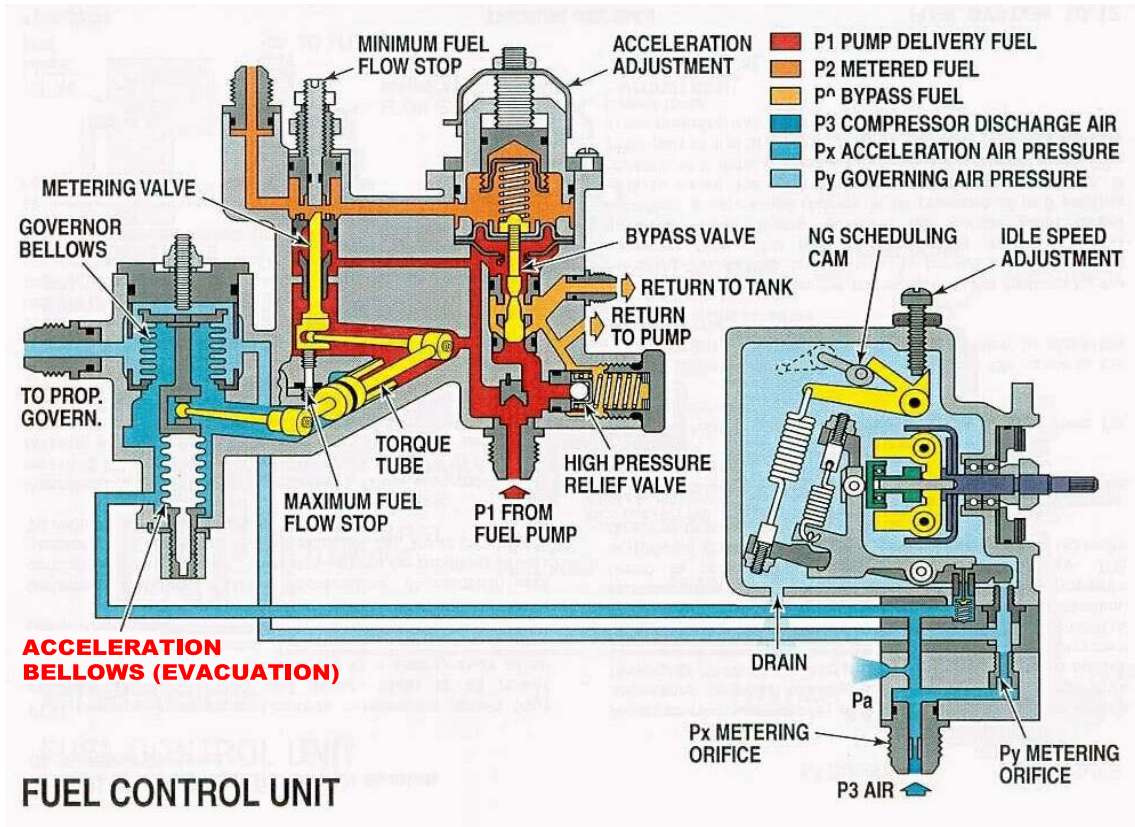
Appendix A - FCU Schematic

The reason for the engine power loss, or roll-back, was a loss of vacuum of the fuel control unit (FCU) acceleration bellows, which resulted in the FCU reducing fuel going to the engine to minimum flow. The loss of the bellows vacuum was due to a breach of the bellows material at a corrosion site, at a time when the compressor discharge air was at its highest pressure--under take-off power conditions. There were no possible actions available to the pilot to restore power to the engine. There is optional equipment available, but not fitted on C-GROO, that would have permitted the restoration of sufficient engine power to maintain a climb. An emergency fuel lever, when used carefully, would have bypassed the FCU acceleration bellows control function and allowed engine operation. The analysis will focus on why the recently-overhauled FCU was being operated with the bellows in a corroded state.

Schematic of the PT6A Fuel Control Unit
